# Fire Risk

Long Bolted Flangeless Valves

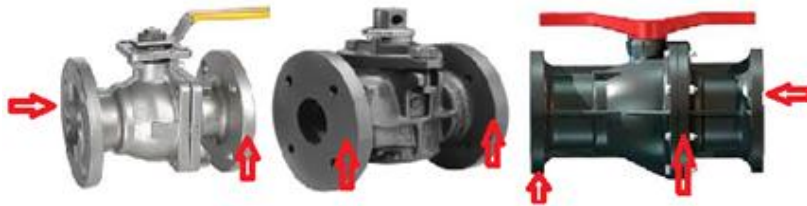
Two major types of valve fittings used in process piping systems are flanged valves and flangeless valves. With flanged valve bodies, there is an exposed lip that allows short bolts to connect it to the extended pipeline system (shown in the following figures). A flangeless valve body has no lip and is commonly attached by two upper or lower long bolts to align in place into a piping system (shown in the following figures). A flangeless valve may also be known as a wafer valve.

**Flanged Valves (Red Arrows Show Flanged Lips on Valve Bodies)**

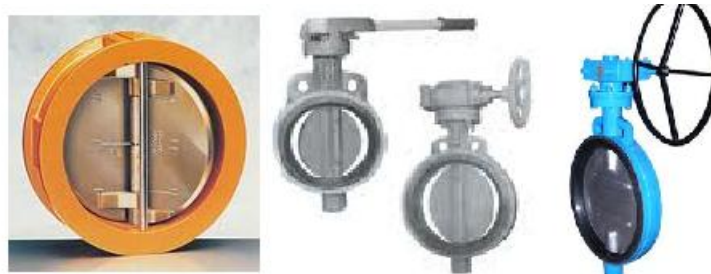
**Flangeless Valves**
